Manhole Inspection Summary

Manhole # S37E__043MH

Inspection ☐ Is Incomplete Rating: **5) Immediate Attention Required**

Location Address: **101 e lexington st**

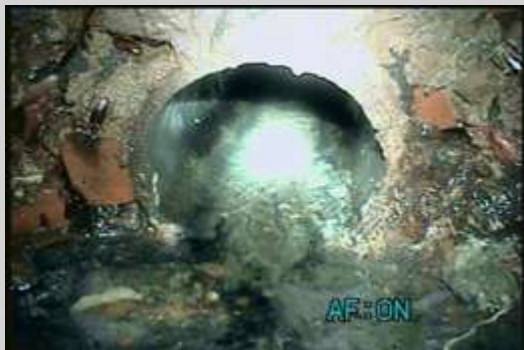
12 O'Clock Outflow

8 in. Circular Gravity Sewer
Pipe Out @ 12 O'Clock

Pipe Material: **Clay** ☐ Pipe Lined

Invert Depth: **12.40** (ft.) Flow Characteristics: **Fast**

Deposits: ☒ None ☐ Mud ☐ Sludge ☐ Debris ☐ Grease

Infiltration: **None** Pipe Seal Cond: **Unknown**

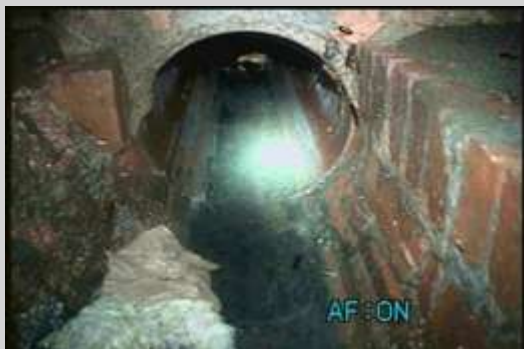
3 O'Clock Inflow

8 in. Circular Gravity Sewer
Pipe In @ 3 O'Clock

Pipe Material: **Clay** ☐ Pipe Lined

Invert Depth: **12.25** (ft.) Flow Characteristics: **Slow**

Deposits: ☒ None ☐ Mud ☐ Sludge ☐ Debris ☐ Grease

Infiltration: **None** Pipe Seal Cond: **Unknown**

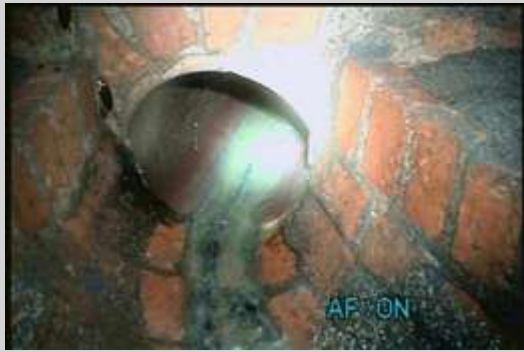
6 O'Clock Inflow

8 in. Circular Gravity Sewer

Pipe In @ 6 O'Clock

Pipe Material: **Clay** ☐ Pipe Lined

Invert Depth: 12.10 (ft.) Flow Characteristics: **Fast**

Deposits: ☒ None ☐ Mud ☐ Sludge ☐ Debris ☐ Grease

Infiltration: **None** Pipe Seal Cond: **Unknown**

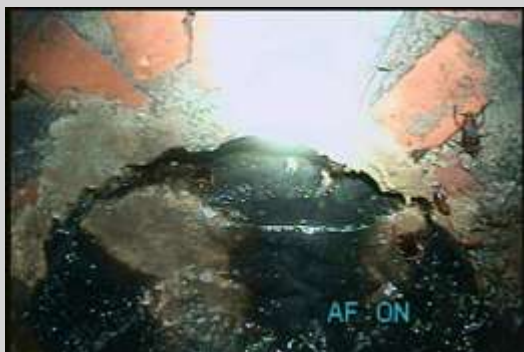
9 O'Clock Inflow

10 in. Circular Gravity Sewer

Pipe In @ 9 O'Clock

Pipe Material: **Clay** ☐ Pipe Lined

Infiltration: **None** Pipe Seal Cond: **Unknown**
